Partial In-Kind Replacement of Stone

Sculptural Detail ***Chase Park Plaza***

Retooling of Ornate Carved Stone Unit

Chase Park Plaza

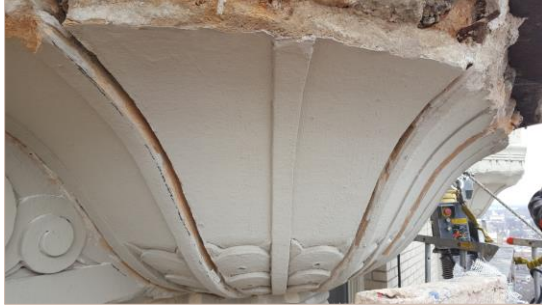
Before

At the bottom of the 25th floor balconies the sculptural stones had been deteriorating and falling. With the stone gone, the steel was also deteriorating.

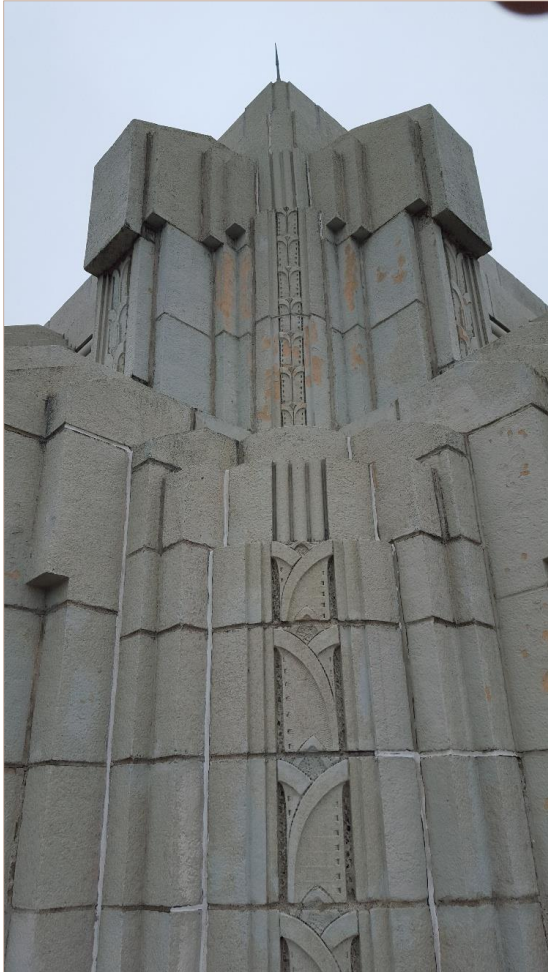
Chase Park Plaza Re-Tooling of Ornate Carved Stone Unit Before

The mortar joints were deteriorated, and the stone was beginning to spall and fall apart.
