Partial In-Kind Replacement of Stone

Partial Face ***The Arcade*** ***Building***

THE ARCADE BUILDING

Masonry Restoration Project

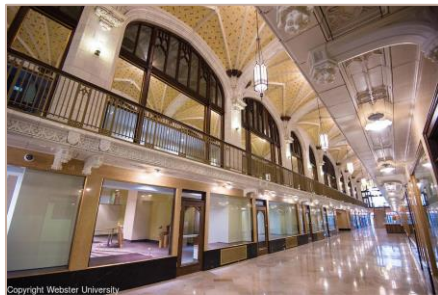
The ornate stone and stone surrounding was damaged and missing along the corridor

Staat provided new ornate and surrounding stone to match the original conditions. The stones were replicated from vintage photos as the pieces were nowhere to be found.

The stone has been reinstalled. The new stone had to be cast and coated to match the original colors from historical photographs.

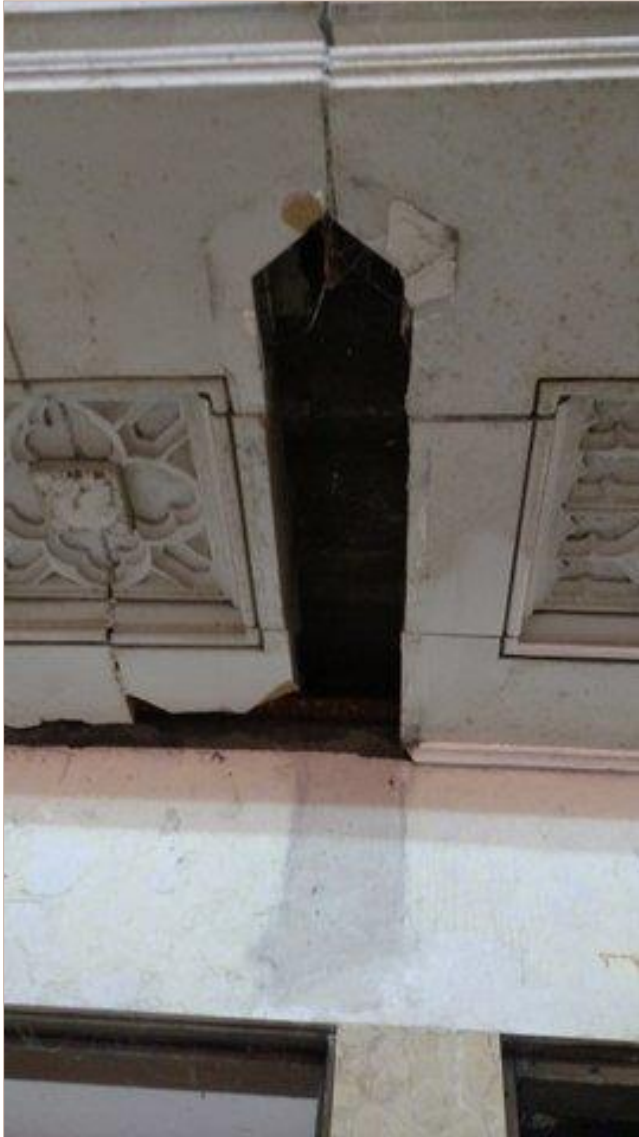
The Arcade Building Partial In-Kind Replacement of Stone Partial Face Before

Before

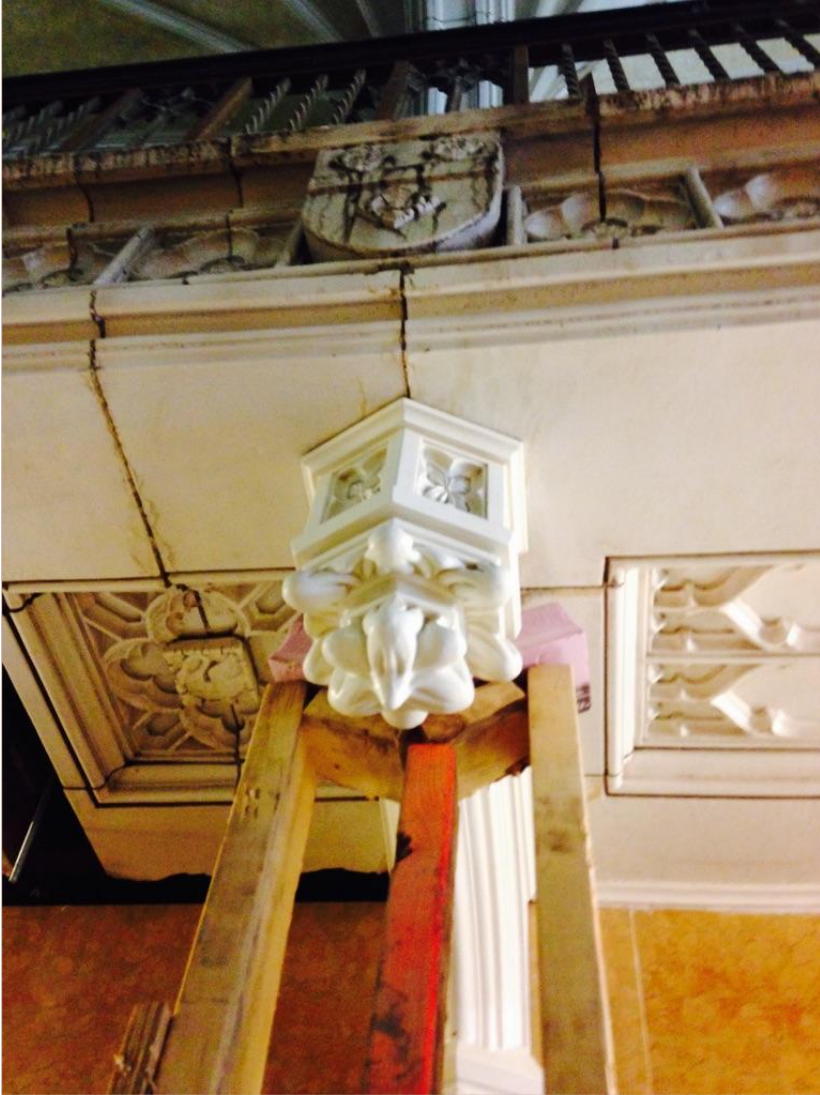
The Arcade Building Partial In-Kind Replacement of Stone Partial Face During

During

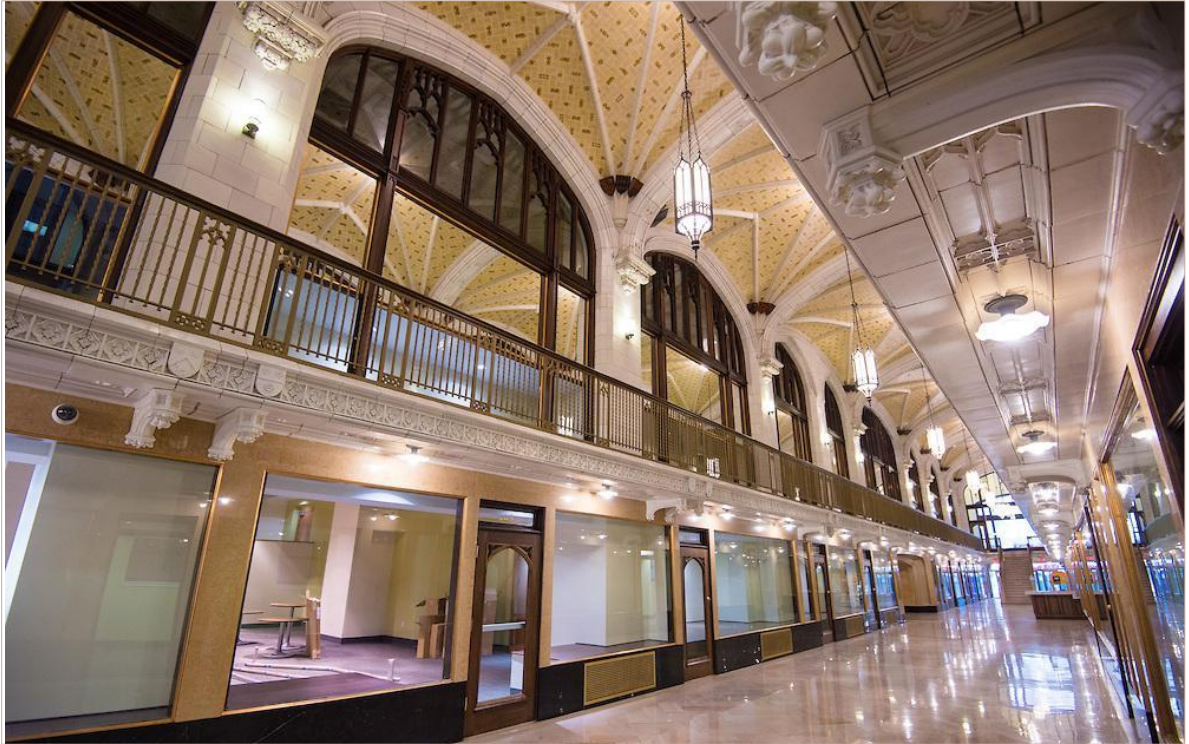
The Arcade Building Partial In-Kind Replacement of Stone Partial Face After

After
